ASiantaeth yr
Amgylchedd
Environment
Agency

River Habitat Survey in Britain and Ireland

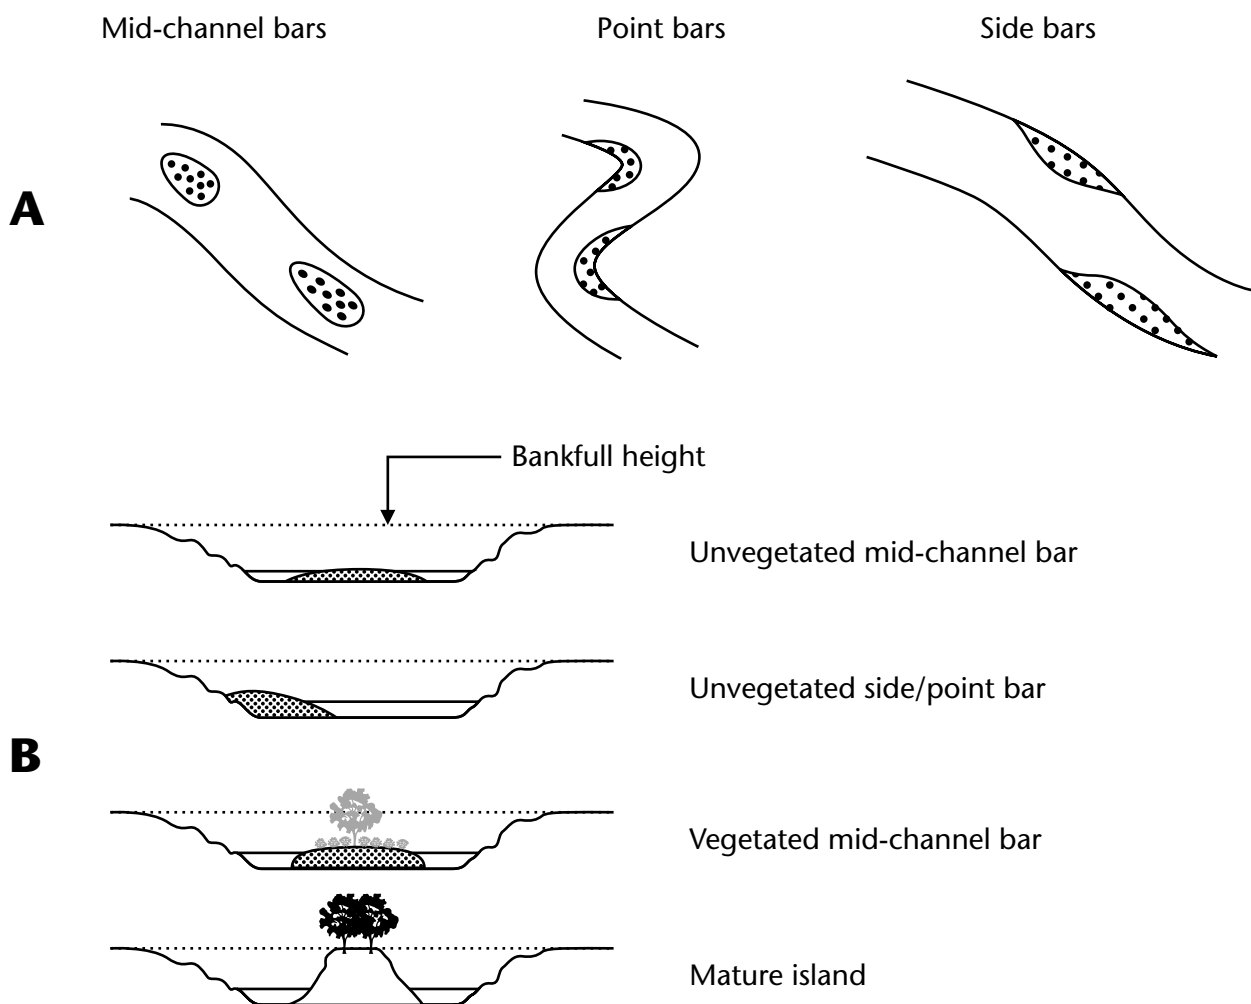
Vegetated side bar (VS)

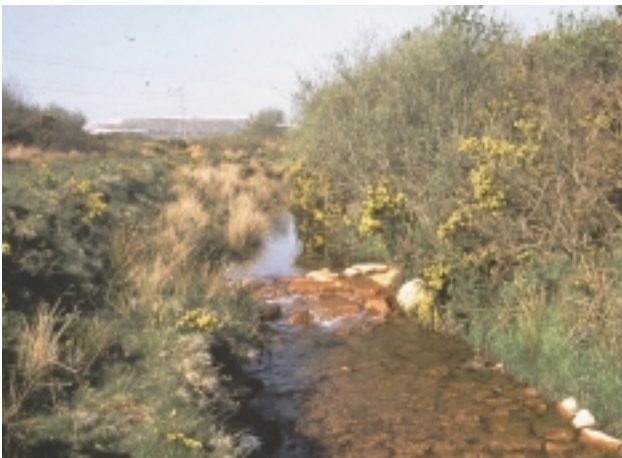
D1c Major weir/sluice – despite small size, the weir structure is 'fixed,' and does not leak water. Note scrub and short grass on right, and short grass and tussocky tall grass on left – both with simple bank vegetation structure. Water upstream is impounded.

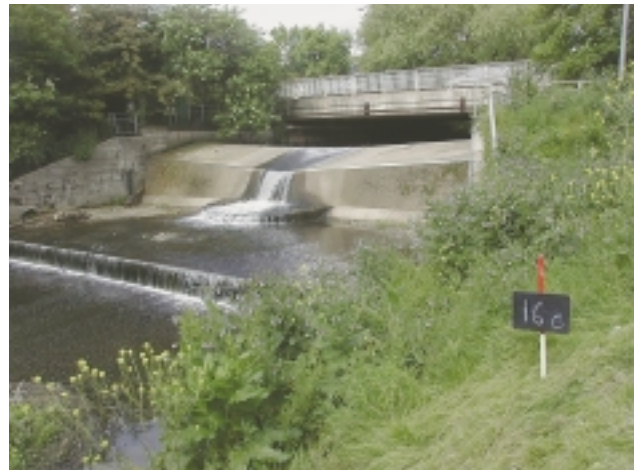
D1d Major weir/sluice – example of a complex weir structure used for measuring flow. Note also an intermediate bridge.

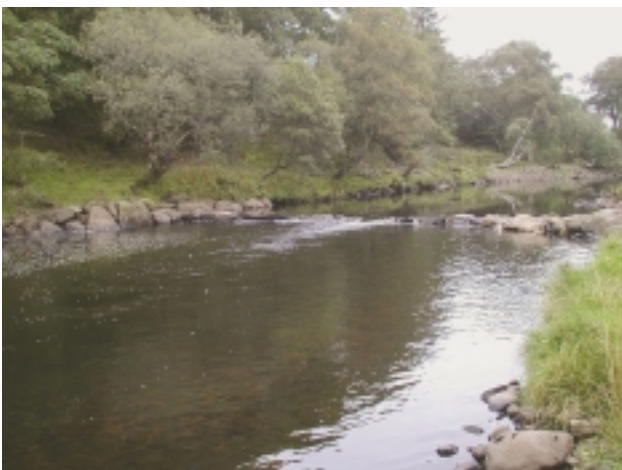
D1e Intermediate weir – boulders are not cemented, and water can leak through the fissures.

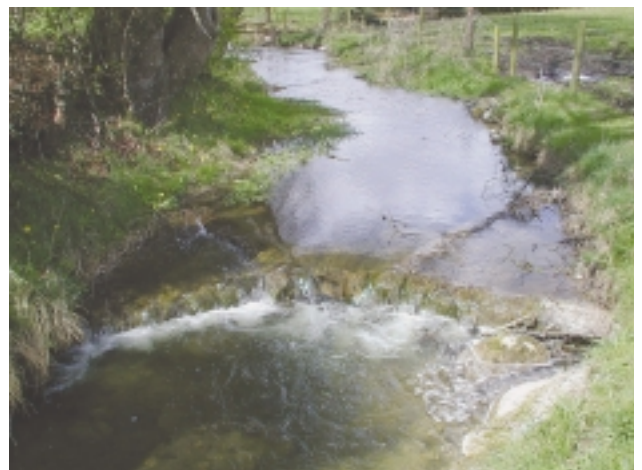
D1f Intermediate weir – wooden log construction, and water can leak through gaps.

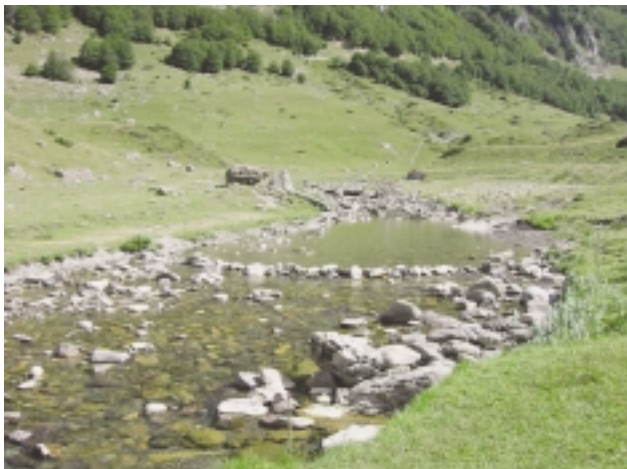
D1g Minor weir – a temporary structure; often built by children from boulders and cobbles.

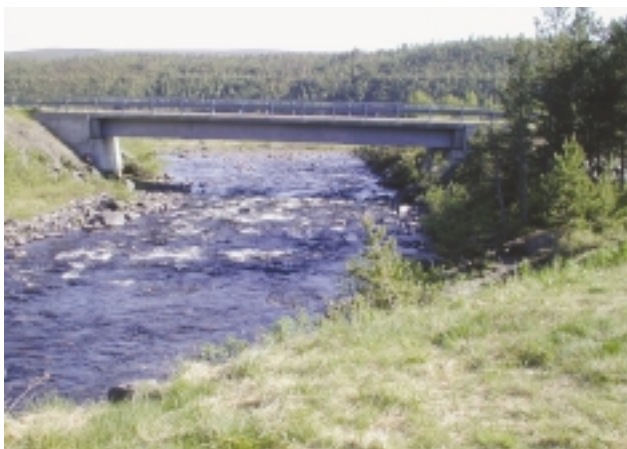
D3c Intermediate bridge – no central piers, and with bank-side abutments 10-25m long. Note broken standing waves.

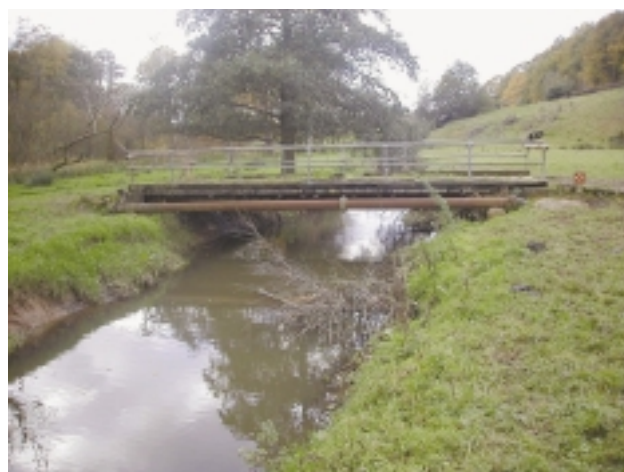
D3d Minor bridge – farm track bridges <10m wide are recorded as 'minor'.

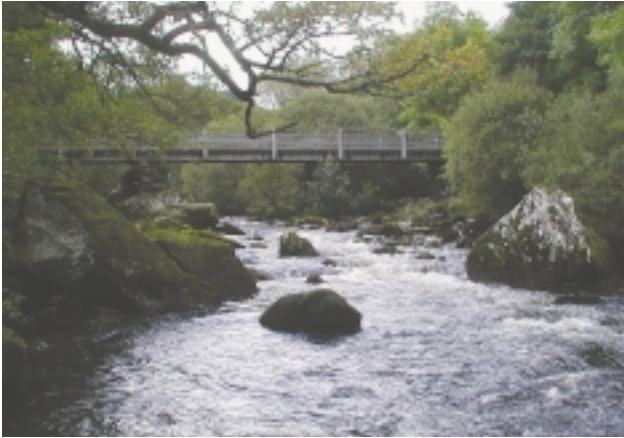
D3e Minor bridge – pipelines crossing rivers, if lacking central piers, are recorded as minor bridges. See also Na. Note exposed boulders and broken standing waves.

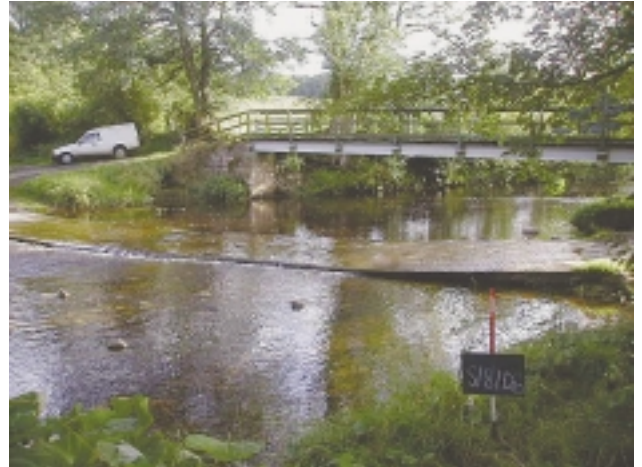
D3f Minor bridge – bridge lacks in-channel supports and has bank abutments <10m wide. Note major ford in fore-ground.

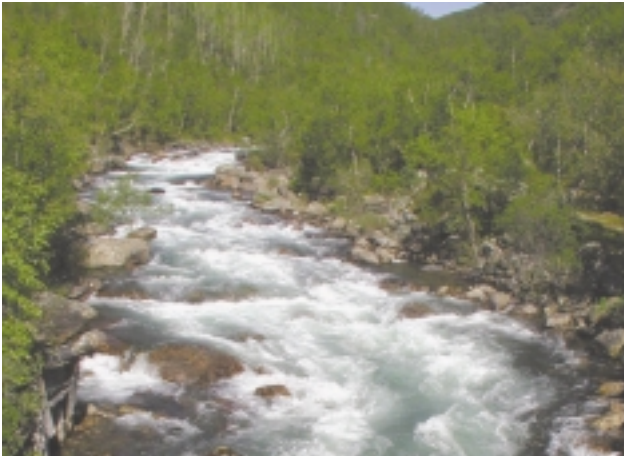
E1Ba Boulder bank material. Note broken standing waves.

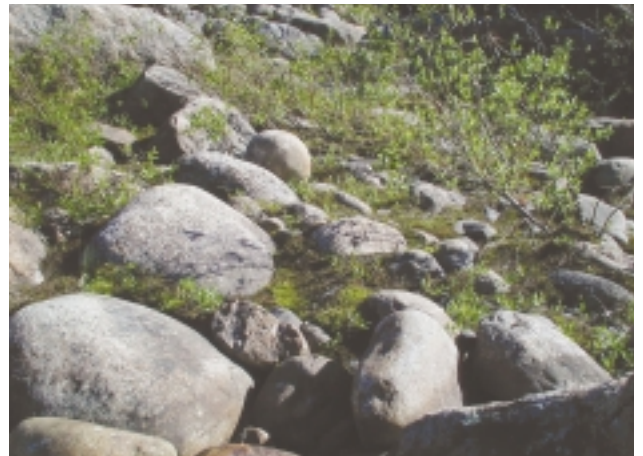
E1Bb Boulder bank material.

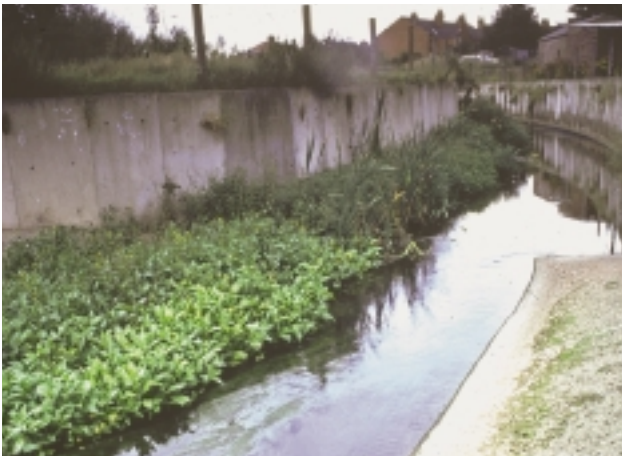
E1Hb Concrete bank material. This example illustrates an artificial berm as habitat creation as part of a flood defence scheme, and this should be noted in Section P.

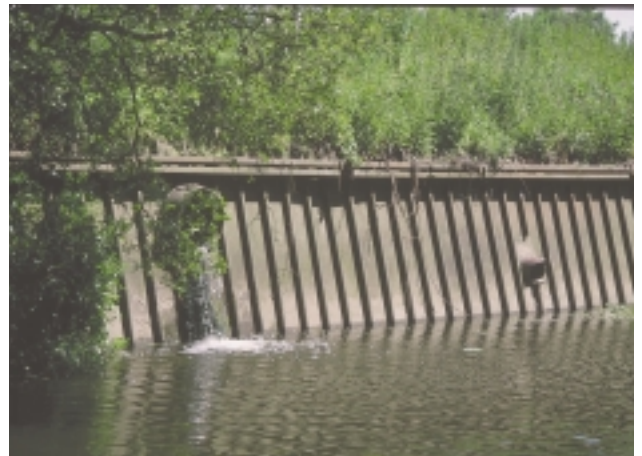
E1Ia Sheet piling bank material.

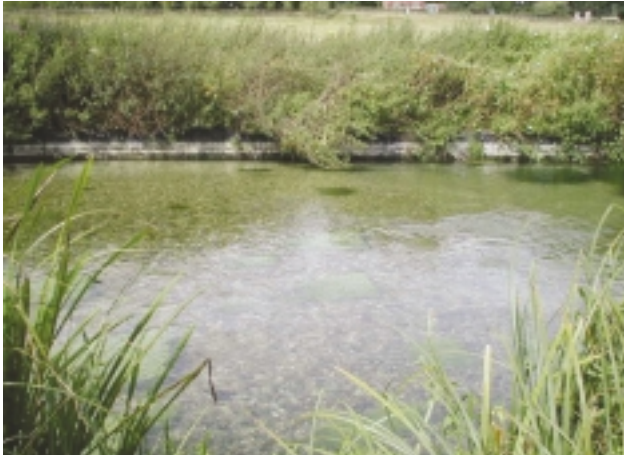
E1Oa Fabric bank material – non-degradable sheet ('nicospan'). Note tall herb bank vegetation above, so record structure as 'simple'.

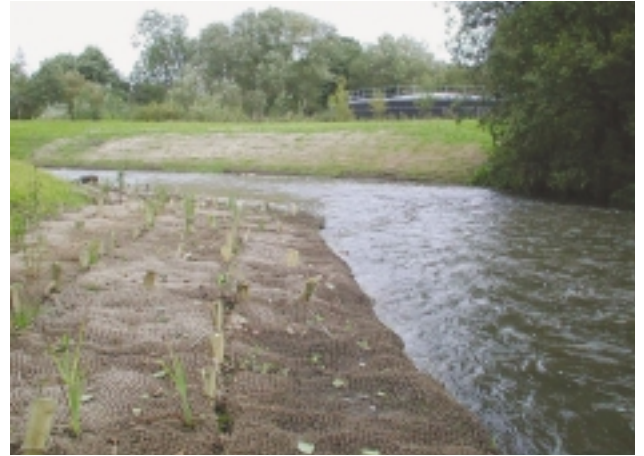
E1Pa Bio-engineering bank materials – bio-degradable matting with vegetation planting. Record bank vegetation structure as 'bare'.

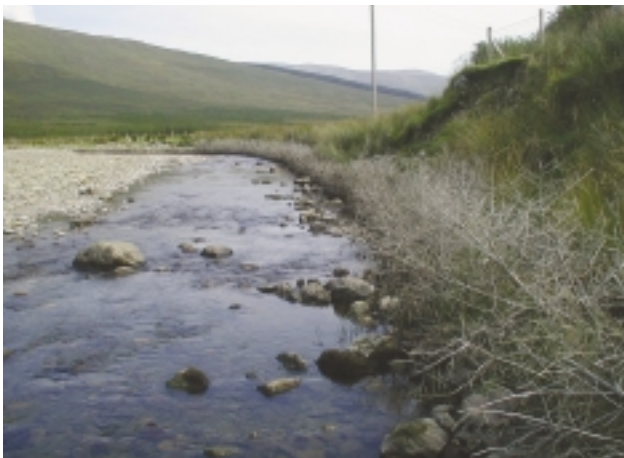
E1Pb Bio-engineering bank materials – brushwood. Note shallow vee valley.

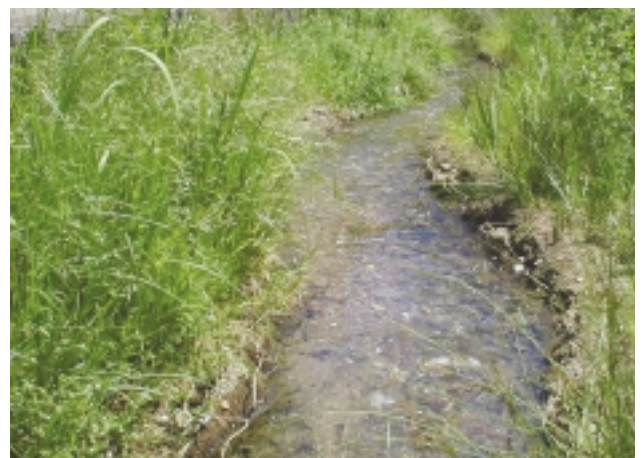
E1Pe Bio-engineering bank materials – here bio-degradable hessian has been used in combination with reed planting and other vegetation.

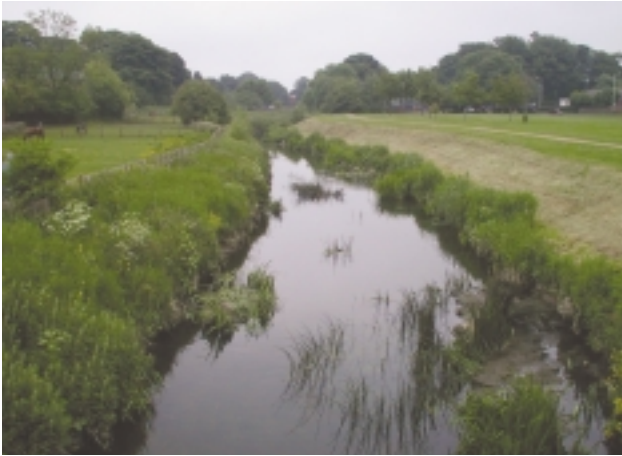
E2Aa Resectioned (reprofiled) bank – tell-tale smooth (trapezoidal) slope even though undertaken many years ago; river also over-deepened, with tell-tale ‘step’ in the profile where bed material at the base of the bank removed. See also A1a, D8a,b,c, E3Da, I6b.

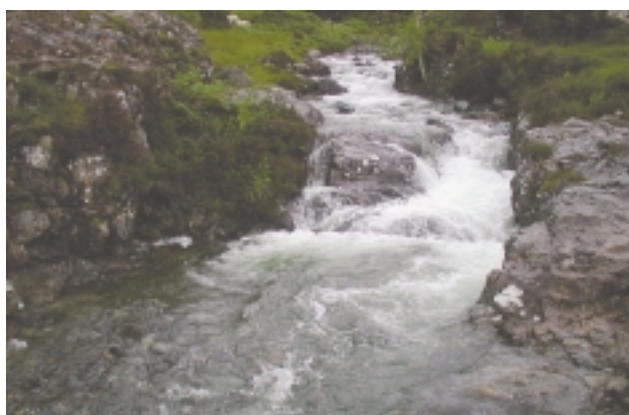
E5Ca Broken standing waves flow-type – typical turbulent white water waves. See also B3c, D3e, E1Ba, E4Ba.

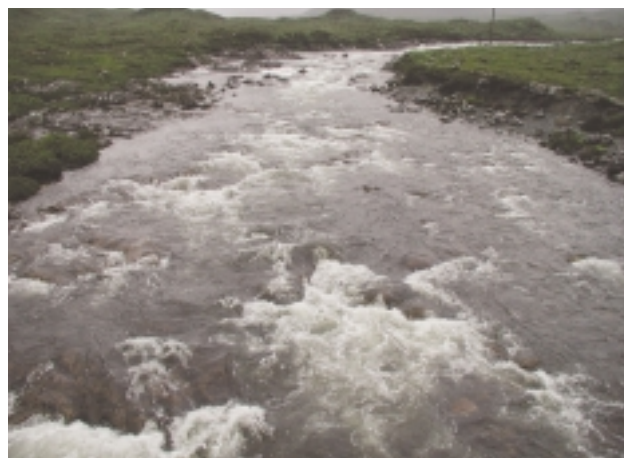
E5Cb Broken standing waves flow-type - typical turbulent white water waves.

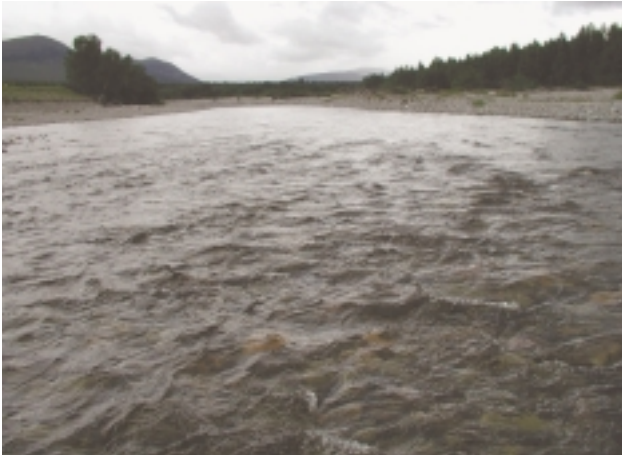
E5Da Unbroken standing waves – surface like 'dragon-back', but waves not broken. See also C1a,b.

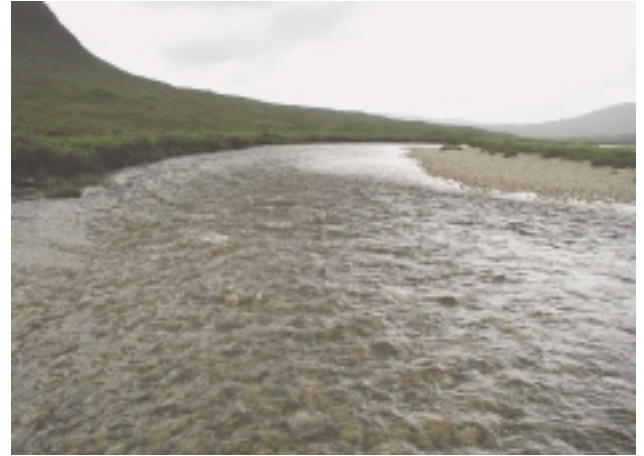
E5Db Unbroken standing waves - surface like 'dragon-back', but waves not broken.

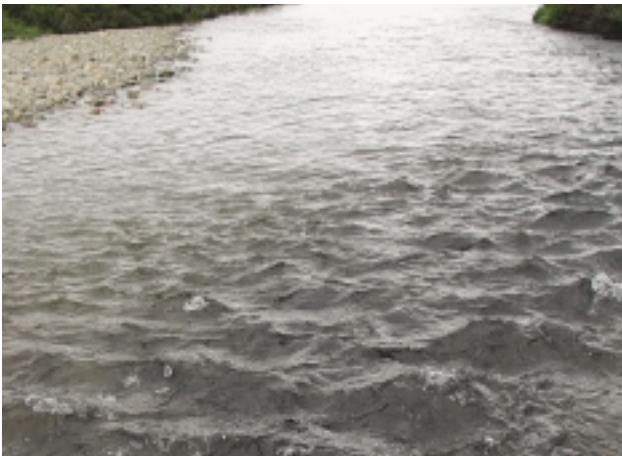
E5Dc Unbroken standing waves - surface like 'dragon-back', but most waves not broken.

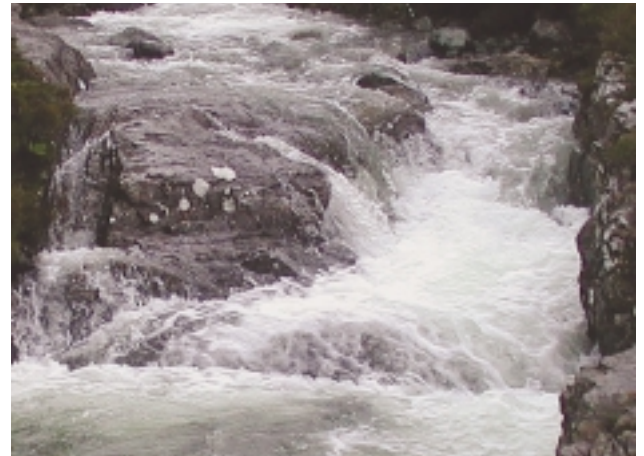
E5Ea Chaotic flow-type – Rare mix of three of the four most turbulent flow-types (free fall, chute, broken standing waves and upwelling) In centre of photo.

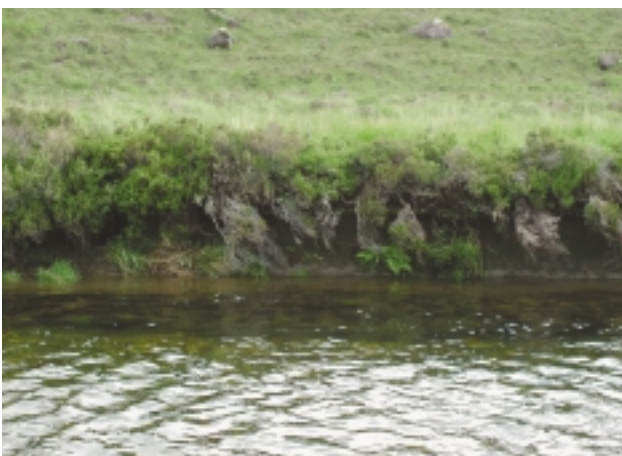
E5Fa Rippled flow-type – surface with small, symmetrical, ripples. Note uniform bank vegetation structure.

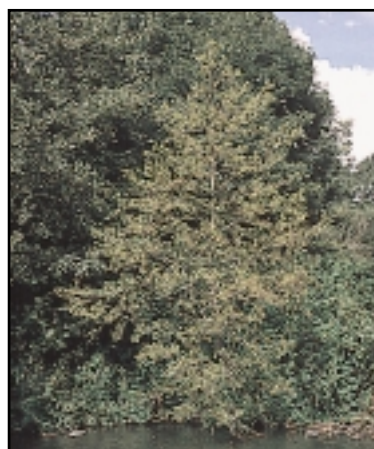
2. From a distance, diseased alders attract attention in mid to late summer because the leaves are abnormally small, yellow and sparse (Figure 1). They frequently fall prematurely, leaving the tree bare. The stem base of a tree with severe crown symptoms is often marked with tarry or rusty spots, sometimes occurring up to two metres from ground level (Figure 2). These spots indicate that the underlying bark is dead. Over the next few years the fine twig structure, the bark and eventually the trunk will break up. However, it is quite common for narrow strips of bark to remain alive and to support a limited growth of new shoots from the trunk and major branches.

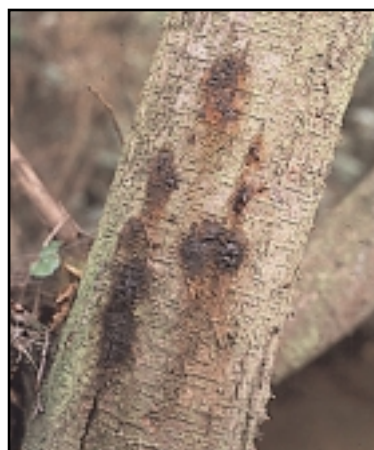
Affected alder stem showing rather sparse yellow foliage typical of Phytophthora disease.

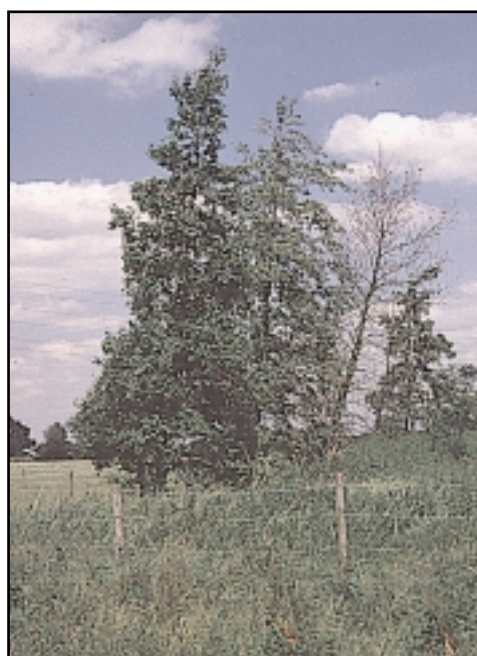
The survey is based on alders (maidens or coppice stools) that have at least one stem of 7 cm dbh. Annual fluctuations in the total number of trees assessed are due to the net effect of recruitment, through growth into the 7 cm size class, and loss, due to activities such as felling or events such as flood. The data show that in 1994 5.2% of the trees were diseased or dead, although it was recognised that a small proportion of the dead trees had not been killed by *Phytophthora*. This percentage has increased each year such that by 1997 8.5% of the total was diseased or dead. By extrapolation from the plot data, it is possible to produce rough estimates of the total numbers of trees affected. This procedure gives a population of 580,000 trees of which 35,000 were diseased and 15,000 were dead.

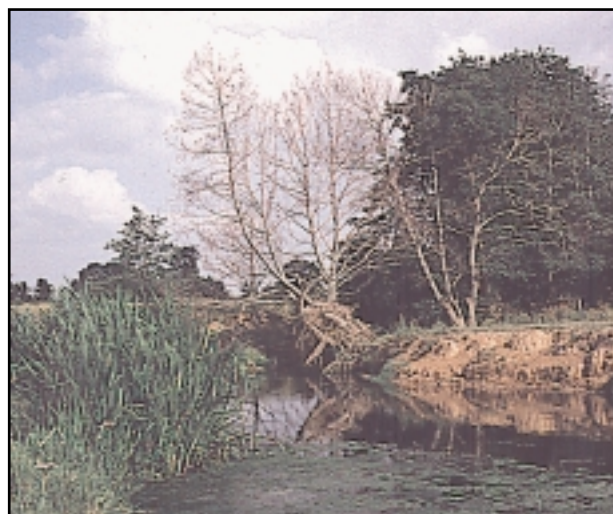
9. The biggest increase was between 1995 and 1996 (Table 1), with the increase between 1996 and 1997 being notably smaller. Scrutiny of the individual plot data for this last year indicates considerable variation, with some plots showing much increase in disease while others show little or none at all. A few trees have definitely recovered from the disease, i.e. there has been no recent death of bark and the leaves are of a normal size and colour, although they may remain sparse. Such trees show the development of new tissues at the edge of basal stem lesions, as described above. It remains to be seen whether this remission from disease is permanent.
10. On average, the disease incidence is highest in south-east England. However, heavy losses are occurring in some of the large alder populations that occur along western rivers - for example, in the Marches (Figure 4).
